## Rescuing History

CURED-IN-PLACE LINING SYSTEM HELPS CONTRACTOR FIX LEAKING STORM DRAINS WHILE PRESERVING THE HISTORIC CHARACTER OF A SOUTH CAROLINA LANDMARK

**PROJECT:** Rehabilitate roof drains at a historic home

**CUSTOMER:** Wallace-McGee house, Columbia, S.C.

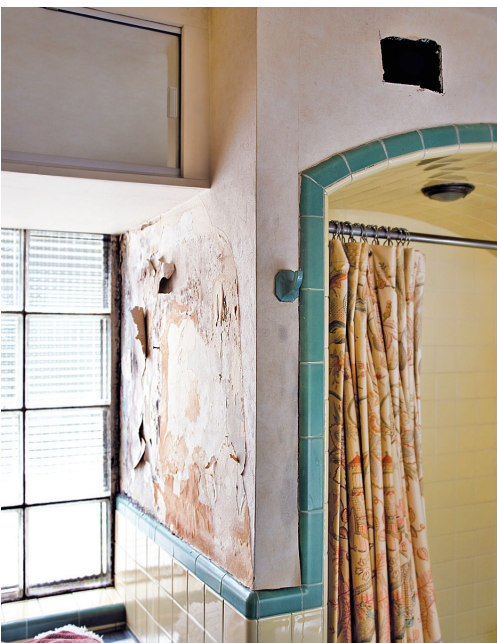
Finally, a plumber sawed a 4-inch-square hole in the wall above the shower stall to expose the west storm drain. Someone had wrapped metal plating around a hole in the 3-inch galvanized pipe and caulked it. The patch had failed.

**Leaks above the second-floor master bath and shower caused the concrete ceiling and exterior shower wall to flake and separate. A previous plumber sawed the 4-inch-square hole above the shower stall to expose the west storm drain.**
